FINAL REPORT OF NONFATAL COAL-MINE BUMP ACCIDENT

MINE NO. 10
WISCONSIN STEEL COAL MINES
INTERNATIONAL HARVESTER COMPANY
BENHAM, HARLAN COUNTY, KENTUCKY

August 19, 1967

J. L. Gilley Mining Health and Safety Engineer

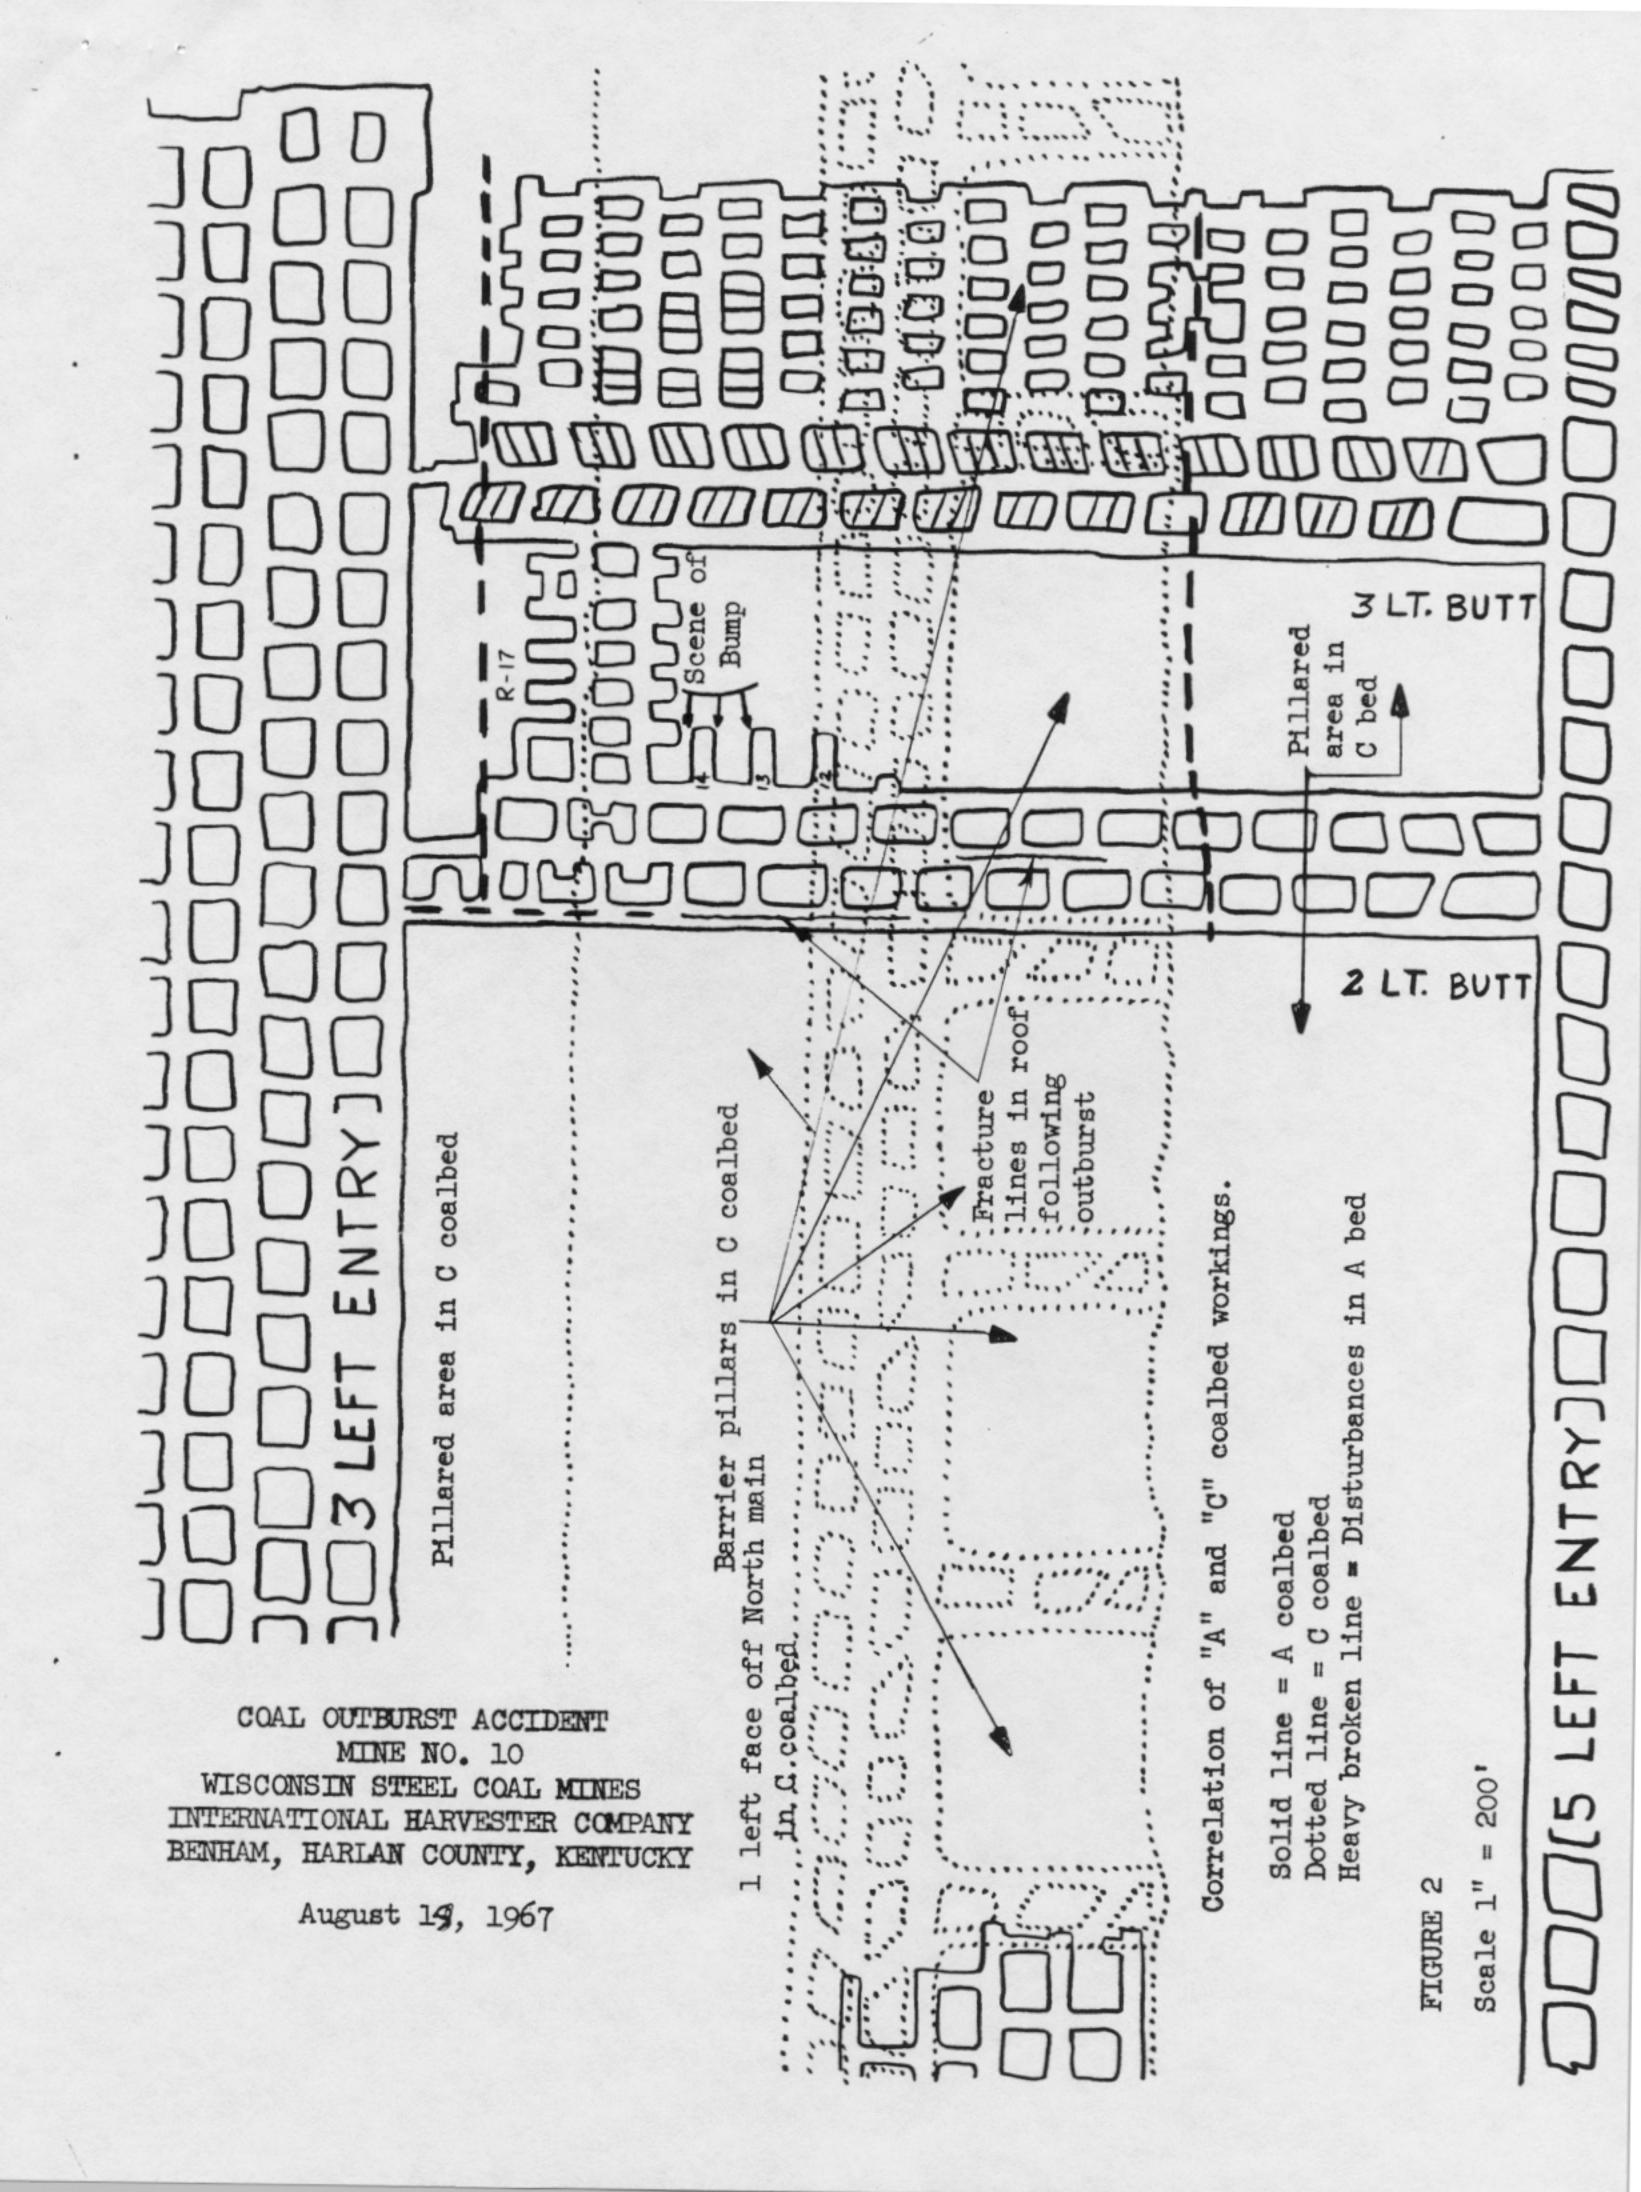
Figures 1 and 2 indicate the mining system used, the extent of the development, final mining of pillars (partial extraction), the comparative dimensions of coal pillars, and the locations of men and equipment at the time of the outburst in the 2 left butt area affected by the bump. Correlation of the 2 left butt workings in the "A" coalbed with the relative projections of unmined pillars and mined-out areas in the superjacent "B" and "C" coalbeds is indicated in Figure 3.
